E 16	Product/assembly/test step	
	Vehicle/engine

Trouble-shooting program

Trouble-shooting program
Porsche

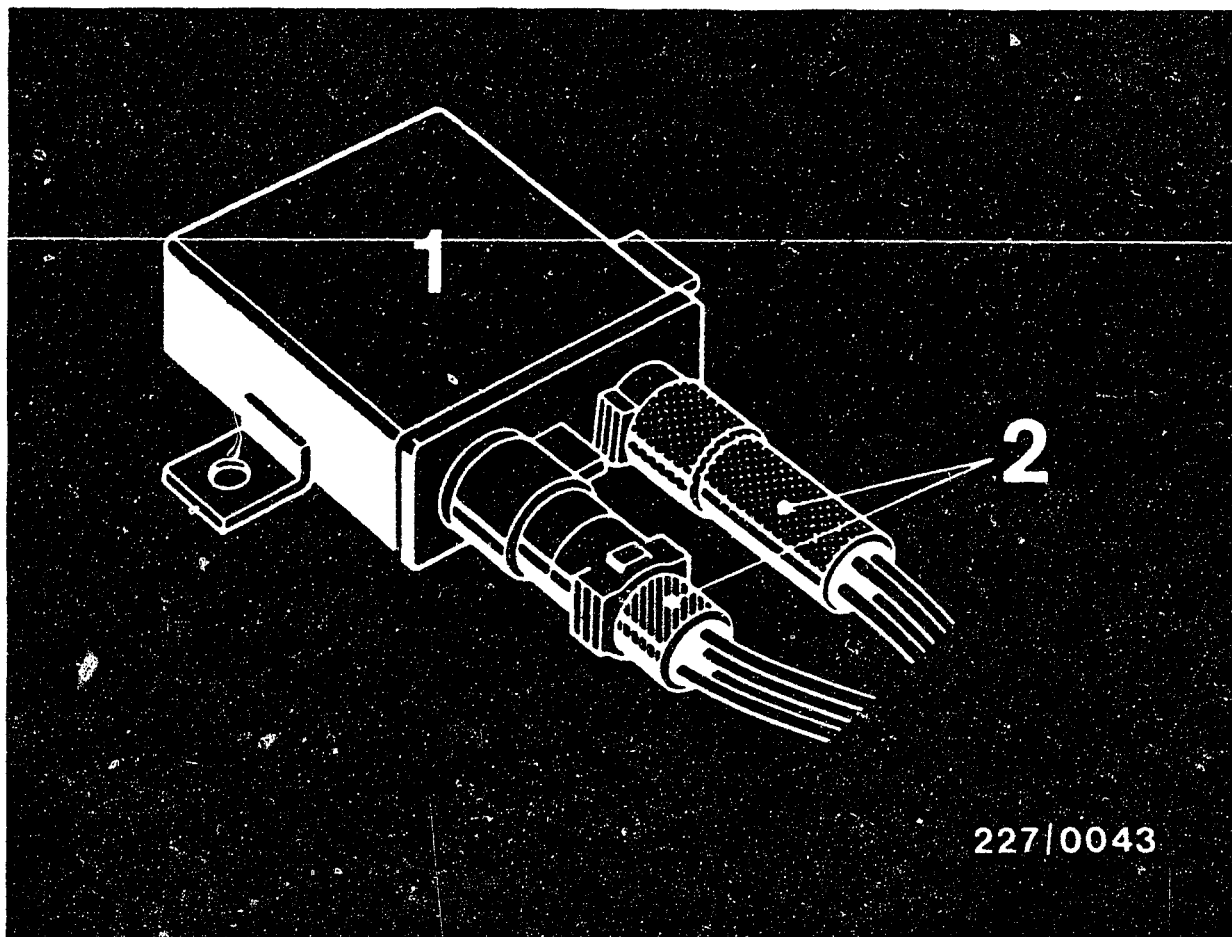
227/0043

Test connectors of ELS unit - if fitted.

Visual examination: Remove both connectors from the ELS unit (see picture) and check the contacts for oxidation and proper latching (remedy defects). Re-connect both connectors to the ELS unit. If customer complaint not remedied, continue testing.

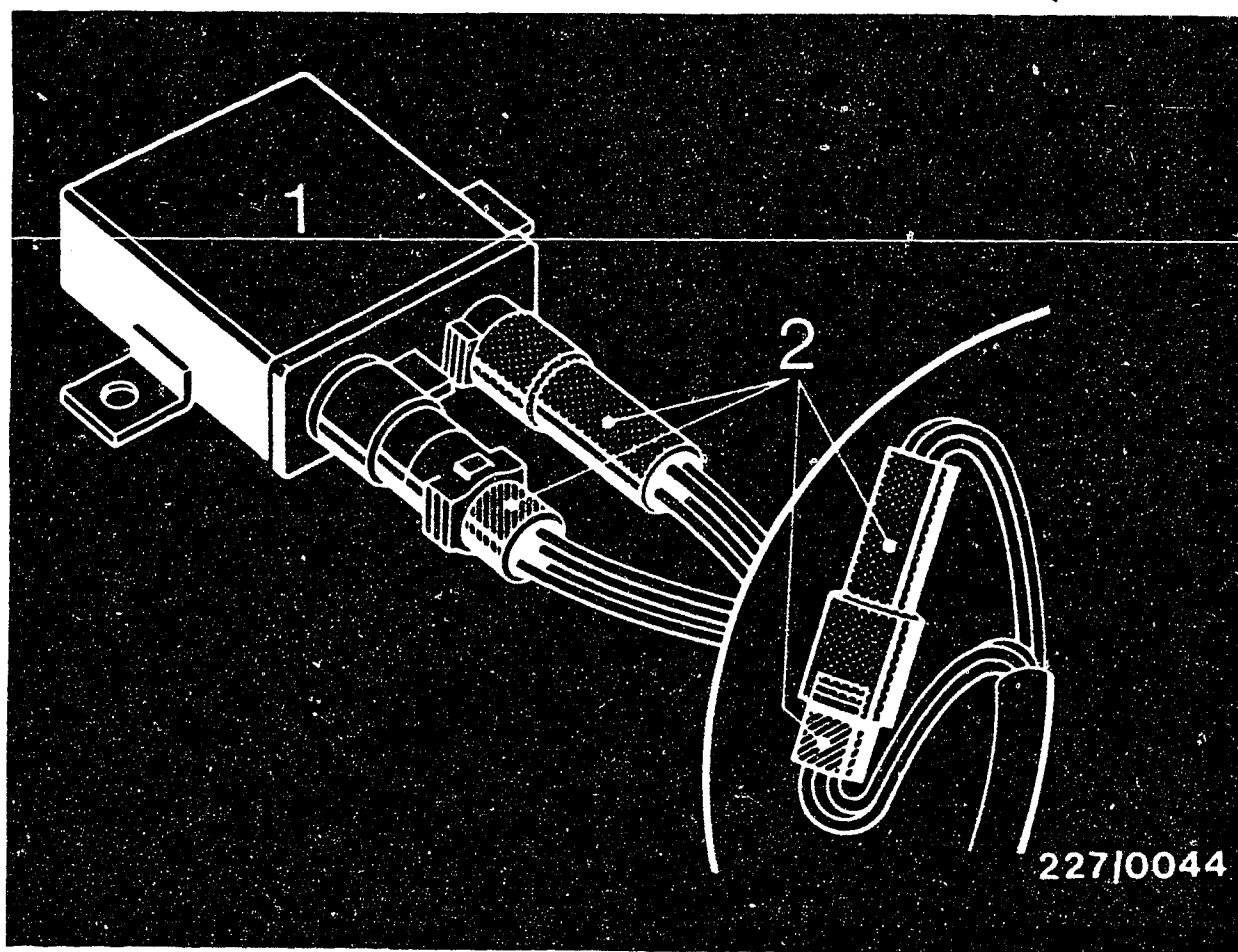
Render ELS unit - if fitted - inoperative.

Remove both connectors from ELS unit (2) and connect together (see picture). If customer complaint now remedied, replace ELS unit. If customer complaint not remedied, continue testing.

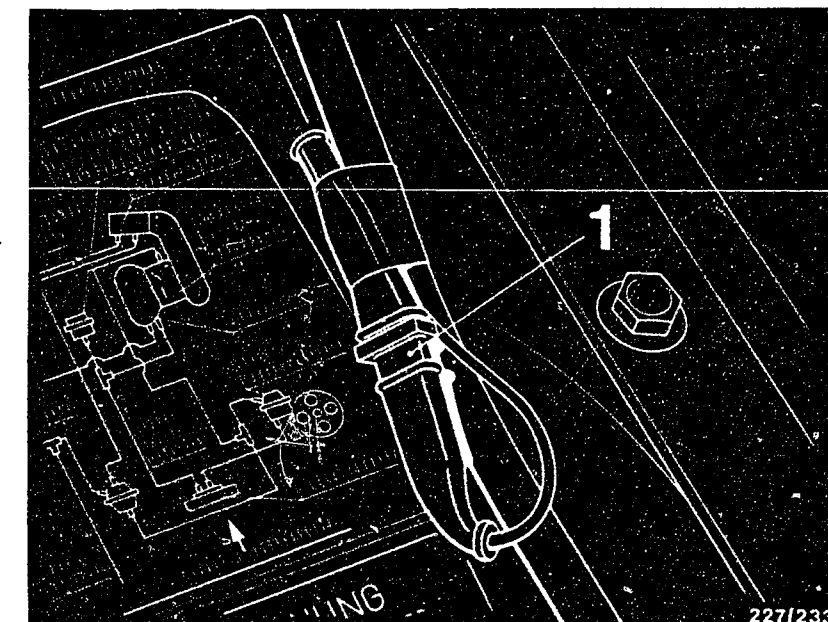
Test initial ignition-timing
adjustment
(Autodata test specifications)

Render the ELS inoperative. To
do this, undo plug-in connection
in engine compartment on left-
hand wheel housing wall. See
picture.
After testing is completed,
restore plug-in connection.

(If there is clearly an incor-
rect indication of engine
speed on testers, connect in
series resistor or convert
motortester).

No Adjust ignition.

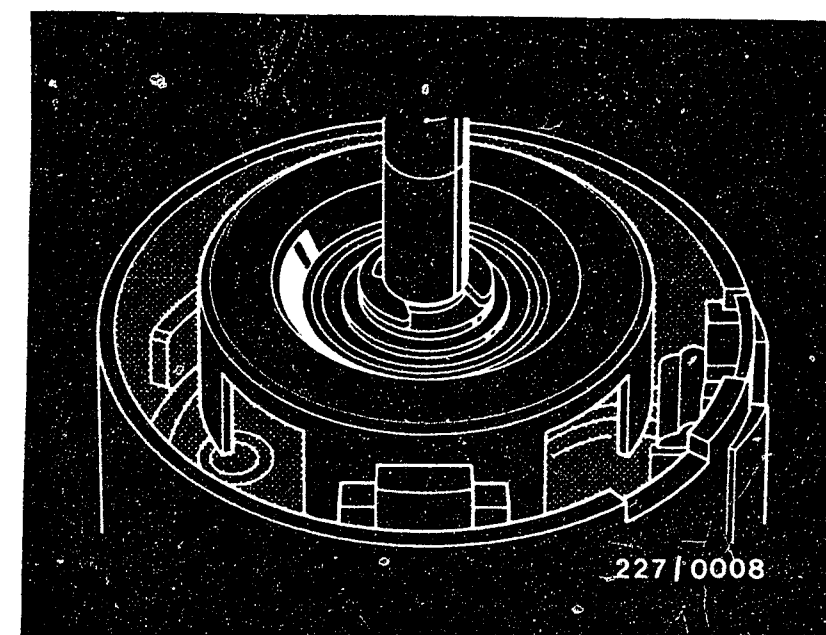
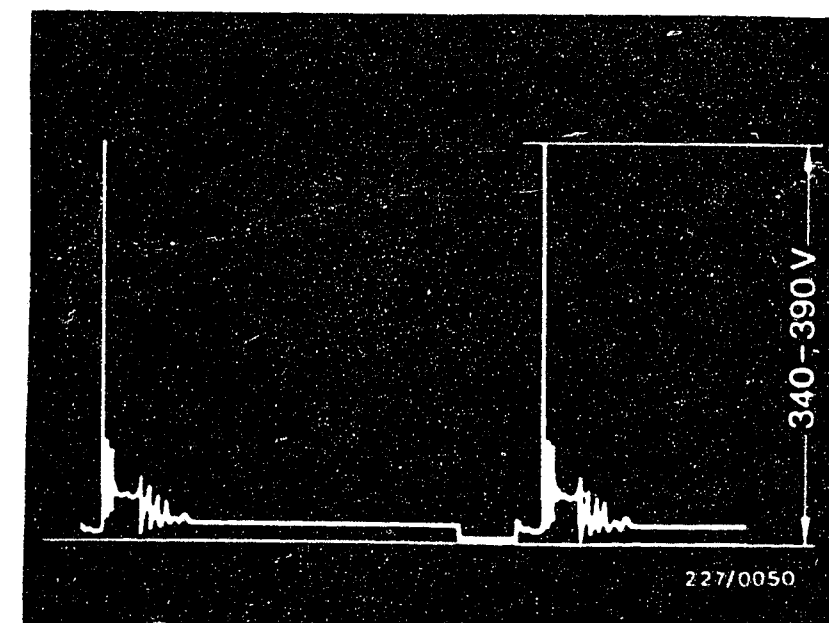
Test peak-coil-current cut-off. Connect voltmeter to ignition coil term. 15 and term. 1. Remove distributor cap, distributor rotor and dust-protection cover. Turn engine over by hand in direction of rotation until vane is completely in air gap of magnetic pickup assembly. See illustration. Switch on ignition. Voltmeter deflects slightly (approx. 5 V) for approx. 1 sec. Voltmeter must return to 0 V. Voltage (0 V) correct?

Test primary voltage (if MOT series available). Connect oscilloscope e.g. MOT 201 to ignition coil as per operating instructions. Let engine idle. Measured primary voltage must be 340...390 V. See graph. Voltage O.K.?

Replace trigger box and ignition coil.

Replace trigger box.

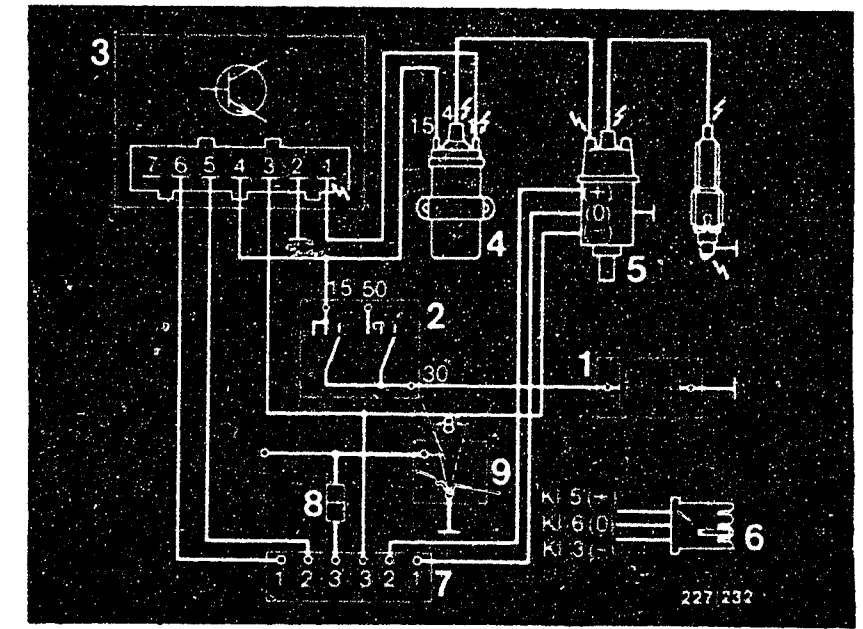
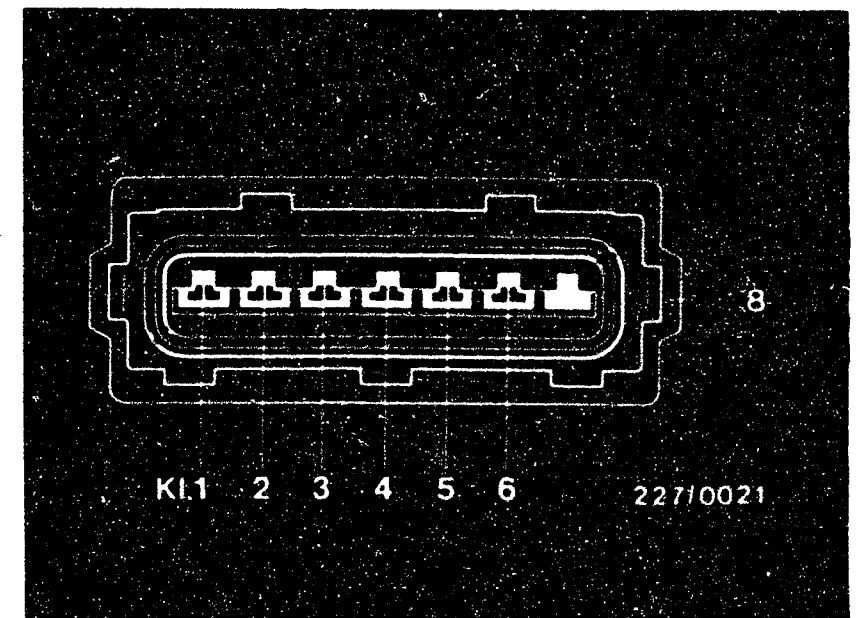
Test trigger box voltage supply.
Remove trigger-box plug.
Connect voltmeter to trigger-box plug
between term. 4 and term. 2.
Switch on ignition.
Voltmeter must indicate battery voltage.
Voltage correct?

Test primary circuit.
Connect voltmeter to disconnected
trigger-box plug between term. 1 and
term. 2.
Switch on ignition.
Voltmeter must indicate battery voltage.
Voltage correct?

Check for open circuit in cables and
terminals from ignition and starting
switch to trigger-box plug term. 4
including ground cable term. 2.
Eliminate open circuit.

Check for open circuit in cable from
ignition and starting switch to
ignition coil term. 15, primary
winding of ignition coil as well as
cable from ignition coil term. 1 to
trigger-box plug term. 1 including
ground cable term. 2. Eliminate open
circuit.

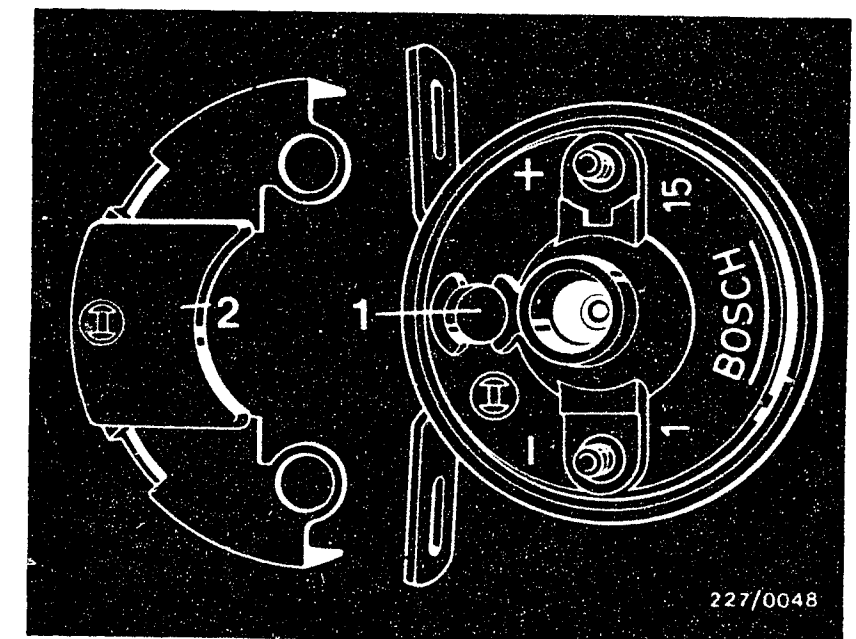
Test ignition coil.

Visual examination: Remove protective cap from ignition coil and check whether plug (see illustration) is in position and whether any sealing compound has escaped.

Electrical test: Ignition coil primary (term. 15 and 1) $0.5 \dots 0.9\Omega$ (take resistance of test lead with test prods into account).
Ignition coil secondary (term. 1 and 4)
 $2,4 \dots 4,4 \text{ k}\Omega$

Plug in position? No sealing compound escaped?

Resistance values O.K.?

1. If plug is not in position and/or sealing compound has escaped, replace trigger box and ignition coil:

2. If resistance values are not O.K., replace ignition coil.

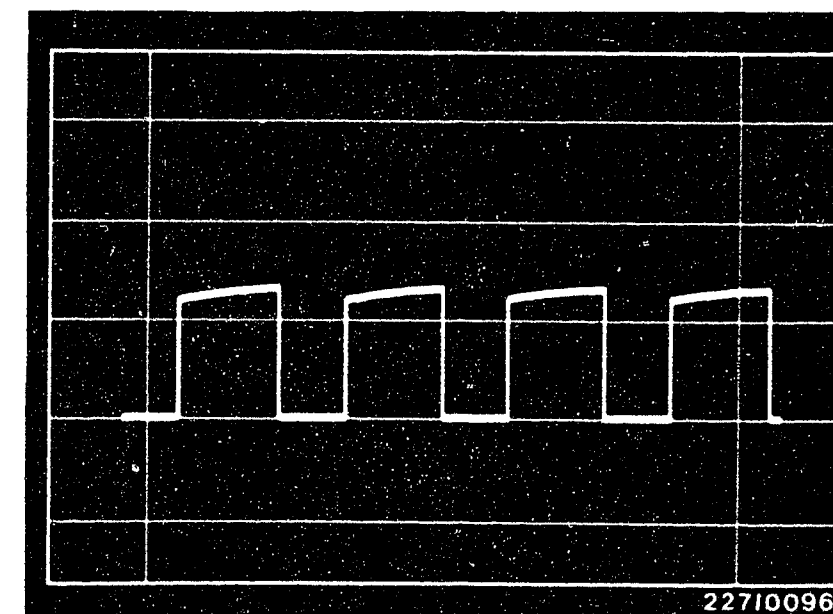
227/0096

Check the pickup assembly. Connect the oscilloscope in the program position "Special" according to the operating instructions.

Is there a rectangular impulse?

Replace pickup assembly or ignition distributor.

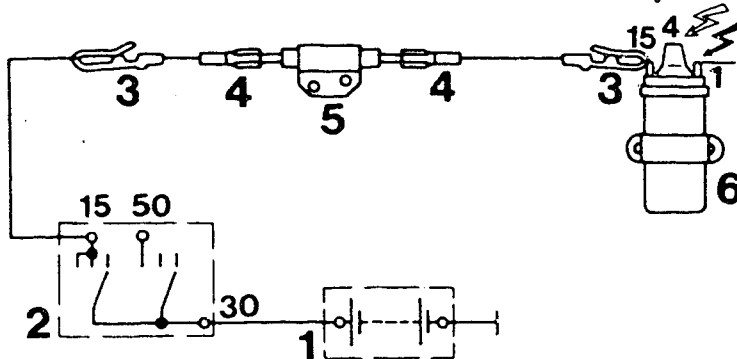
In comparison with conventional ignition systems, transistorized ignition systems with current limitation have different primary voltage characteristics. During the dwell period the voltage at terminal 1 of the ignition coil may assume values from 1.5 V to battery voltage (or greater). This may lead to an incorrect display of rotational speed and dwell angle when testing the ignition system. However, there is no functional defect in the ignition system, and, for this reason, the trigger box must not be replaced. Incorrect displays may occur with the testers listed below:

Connect a ballast resistor of 0.9 or 1.0 Ohm (see Fig.) in series in the line to term. 15 of the ignition coil (take care not to cause a short circuit). After the rotational-speed measurement, the ballast resistor must be removed (otherwise starting difficulties and misfiring). Connect tester as per operating instructions.

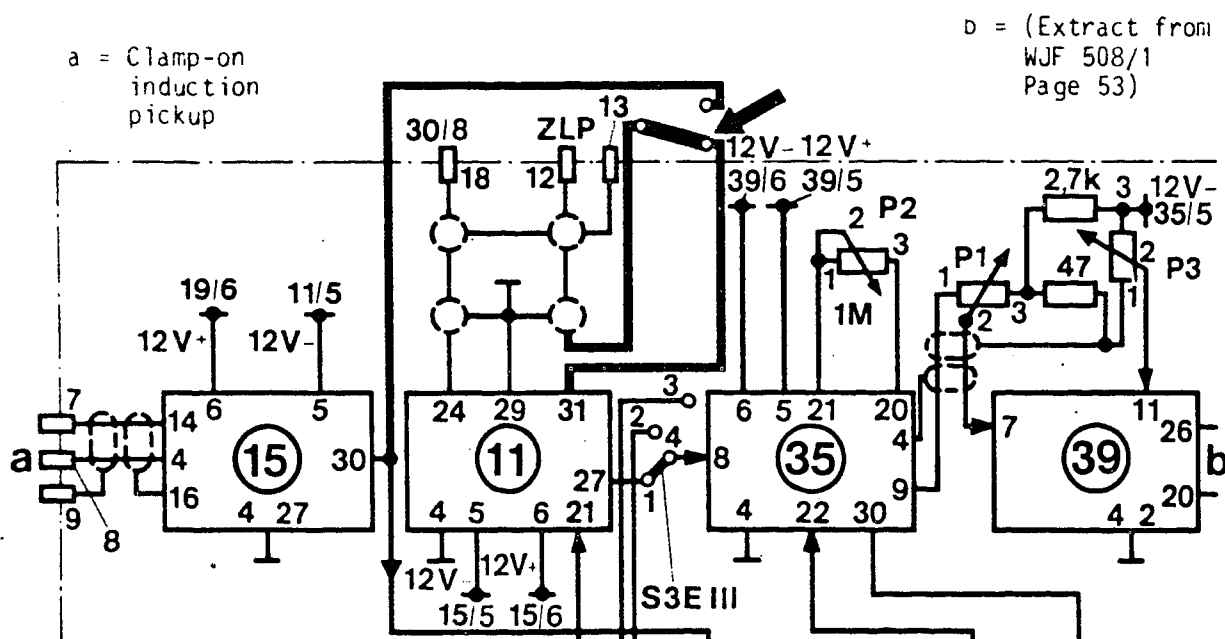
In comparison with conventional ignition systems, transistorized ignition systems with current limitation have different primary voltage characteristics. During the dwell period the voltage at terminal 1 of the ignition coil may assume values from 1.5 V to battery voltage (or greater). This may lead to an incorrect display of rotational speed and dwell angle as well as to incorrect triggering of the meter when testing the ignition system. There is, however, no functional defect in the ignition system, and, for this reason, the trigger box must not be replaced. Since, with the above-listed motortesters, the timing light is triggered by the signal path dwell angle - meter, this incorrect triggering also leads to incorrect flashing and thus to an incorrect display of the advance angle.

Remove the line of the ZLP* from pin 31 of printed board 11 (coupling stage) and connect to pin 30 of printed board 15 (pulse shaper stage) via a switch with change-over contact (e.g. 0 341 500 803). In addition, a new line must be connected from pin 31 of printed board 11 to the other contact of the switch with change-over contact. Arrow points to switch with change-over contact.

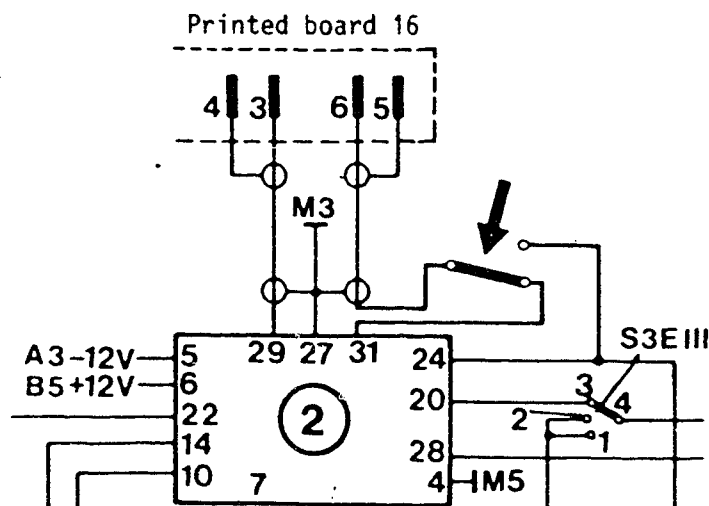
EFAW 214 B

Remove the line from terminal 6 of printed board 16 to pin 31 of printed board 2 (coupling stage) and connect to pin 24 of the same printed board via a switch with change-over contact (e.g. 0 341 500 803). In addition, a new line must be connected from pin 31 of printed board 2 to the other contact of the switch with change-over contact. Arrow points to switch with change-over contact.
